# In Situ Temperature Measurement Test Report

### LIGHT EFFICIENT DESIGN

## **LED Luminaire**

Model name(s):LED-8050M50-HV

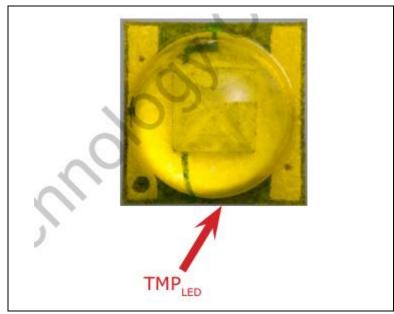
#### Ts Position:

Input	: Vol.	277.0V	Input Curr	ent	ent 1.097A		Input Wa	attage	297.9	V sta	Temperature abilization time:	500 min
No.	Т	emperat	ture (°C)	No.	No. Temperat		ture (°C)	)	No.	Temperature (°C)		
	Moo	sured	Corrected			Measured		Corre	ected		Measured	Corrected
	iviea	sureu	at 25°C					at 2	5°C			at 25°C
1	87.5		87.4	3		86.5		86.4		5	87.2	87.1
2	87.9		87.8	4		86.8		86.7		6	87.9	87.8
The highest in-situ measured temperature LED is 87.8°C
